TECHNICAL REPORT 3576

**A TEST TO DETERMINE THE CAUSE  
OF  
BARREL EROSION  
IN THE  
40 MM M75 LAUNCHER**

**PICATINNY ARSENAL  
DOVER, NEW JERSEY**

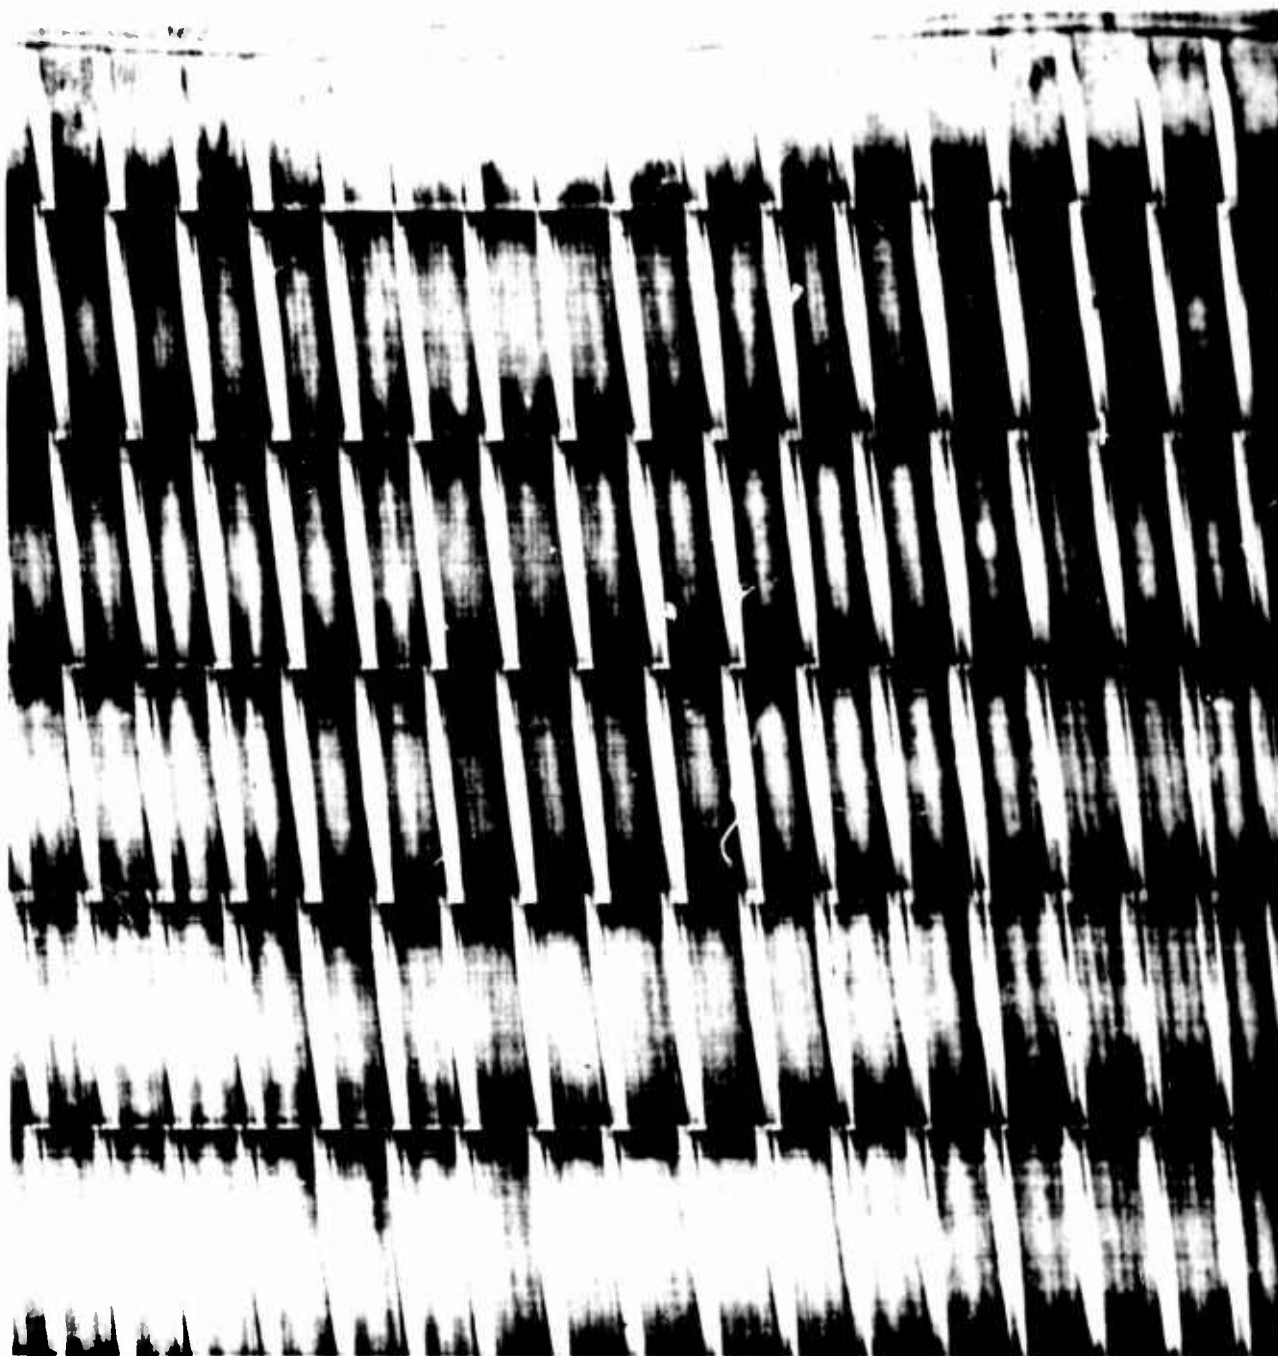
PHOTOGRAPH 8

<u>Rounds Fired</u>	<u>Photograph</u>	<u>Remarks</u>
None	7	---
1,845	8	No visible wear
3,675	9	No visible wear
5,045	10	Slight wear
5,394	11	Slight wear

Borescope Photo of a Chrome - Moly - Vanadium 40mm M75 Weapon barrel  
(No X1) after firing 1845 rounds (25 rd bursts w/cooling after each 150 rds.)  
Ammo M385E1 single chamber.

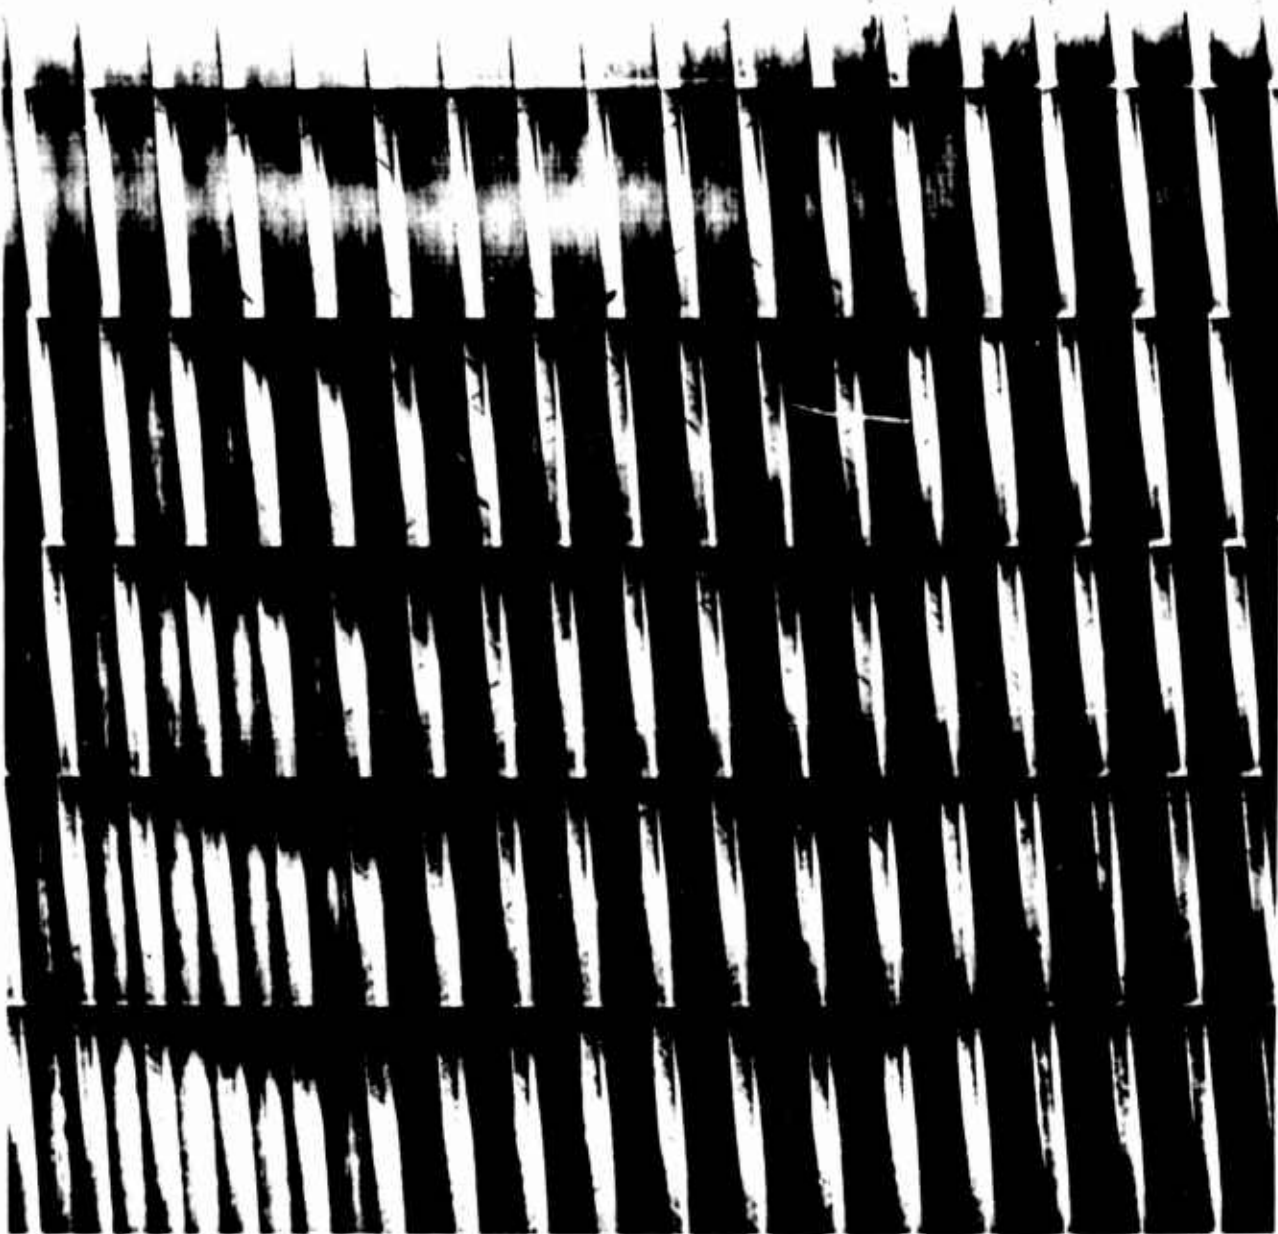
## PHOTOGRAPH 13

<u>Rounds Fired</u>	<u>Photographs</u>	<u>Remarks</u>
None	12	New Barrel
1,805	13	No visible wear
3,598	14	No visible wear
5,020	15	No visible wear
5,319	16	No visible wear

Borescope photograph of 40mm M75 Barrel #A-72 (4147 steel) after firing 1805 rds of M385 ammunition (tale added to propellant). Firing schedule 25 round bursts with cooling at 150 round increments.

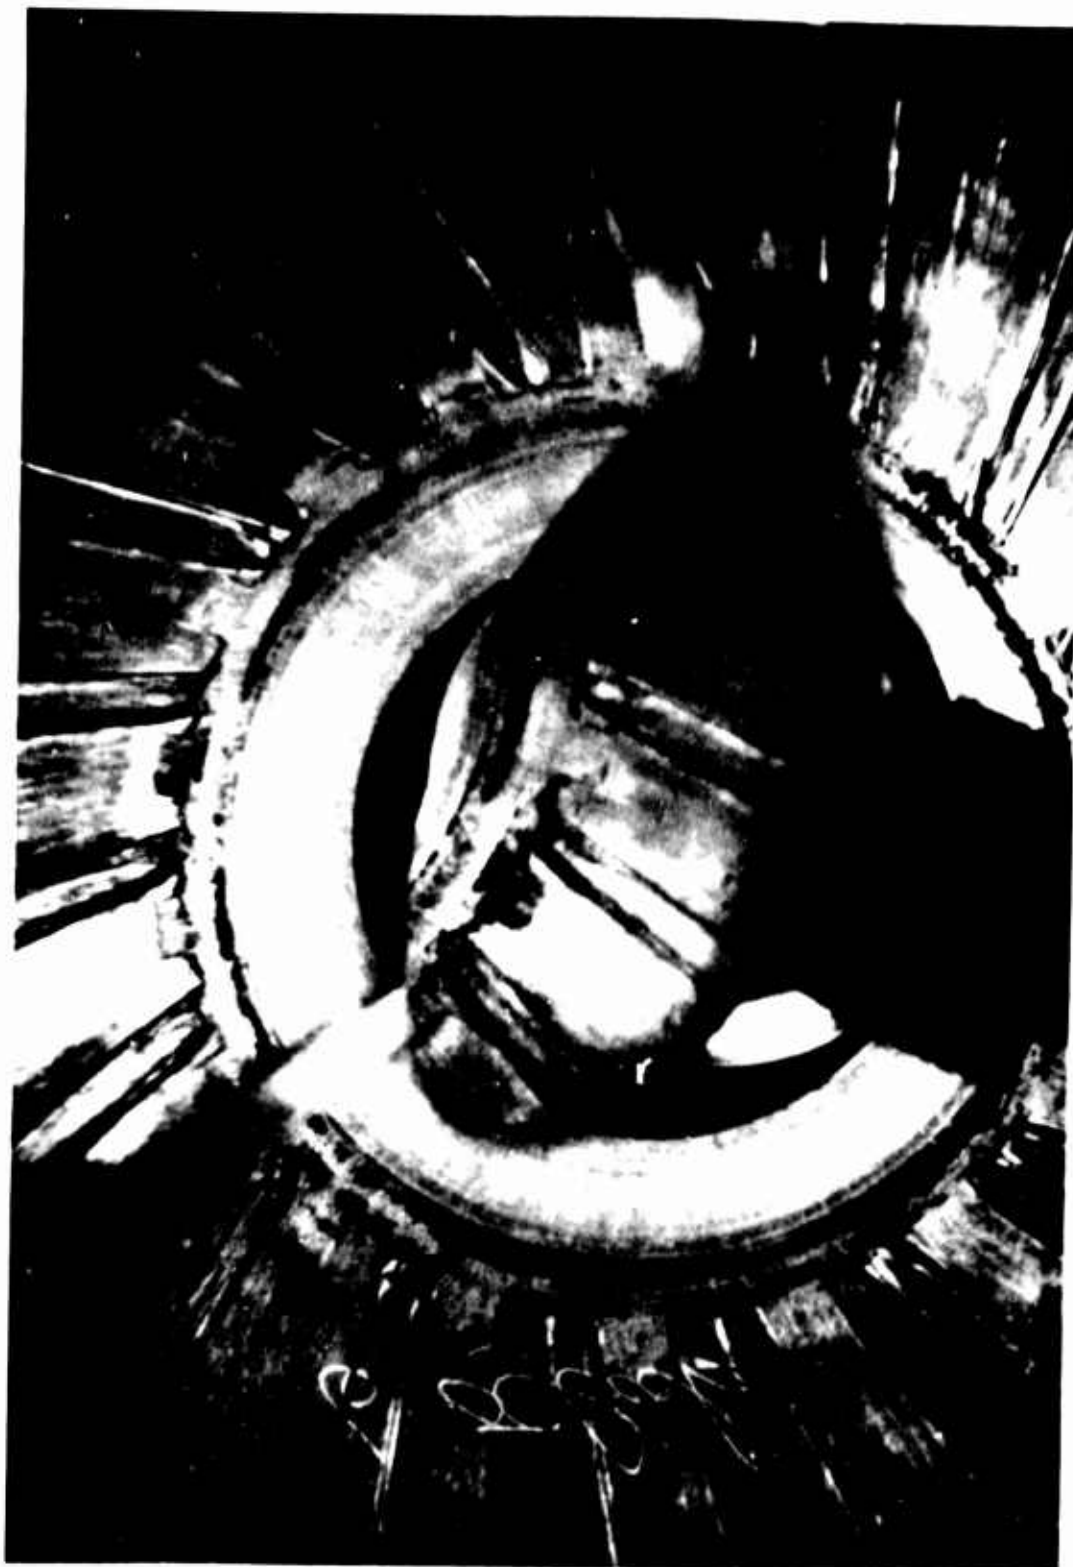
PHOTOGRAPH 26

40mm M41 Barrel after 3500 rounds.

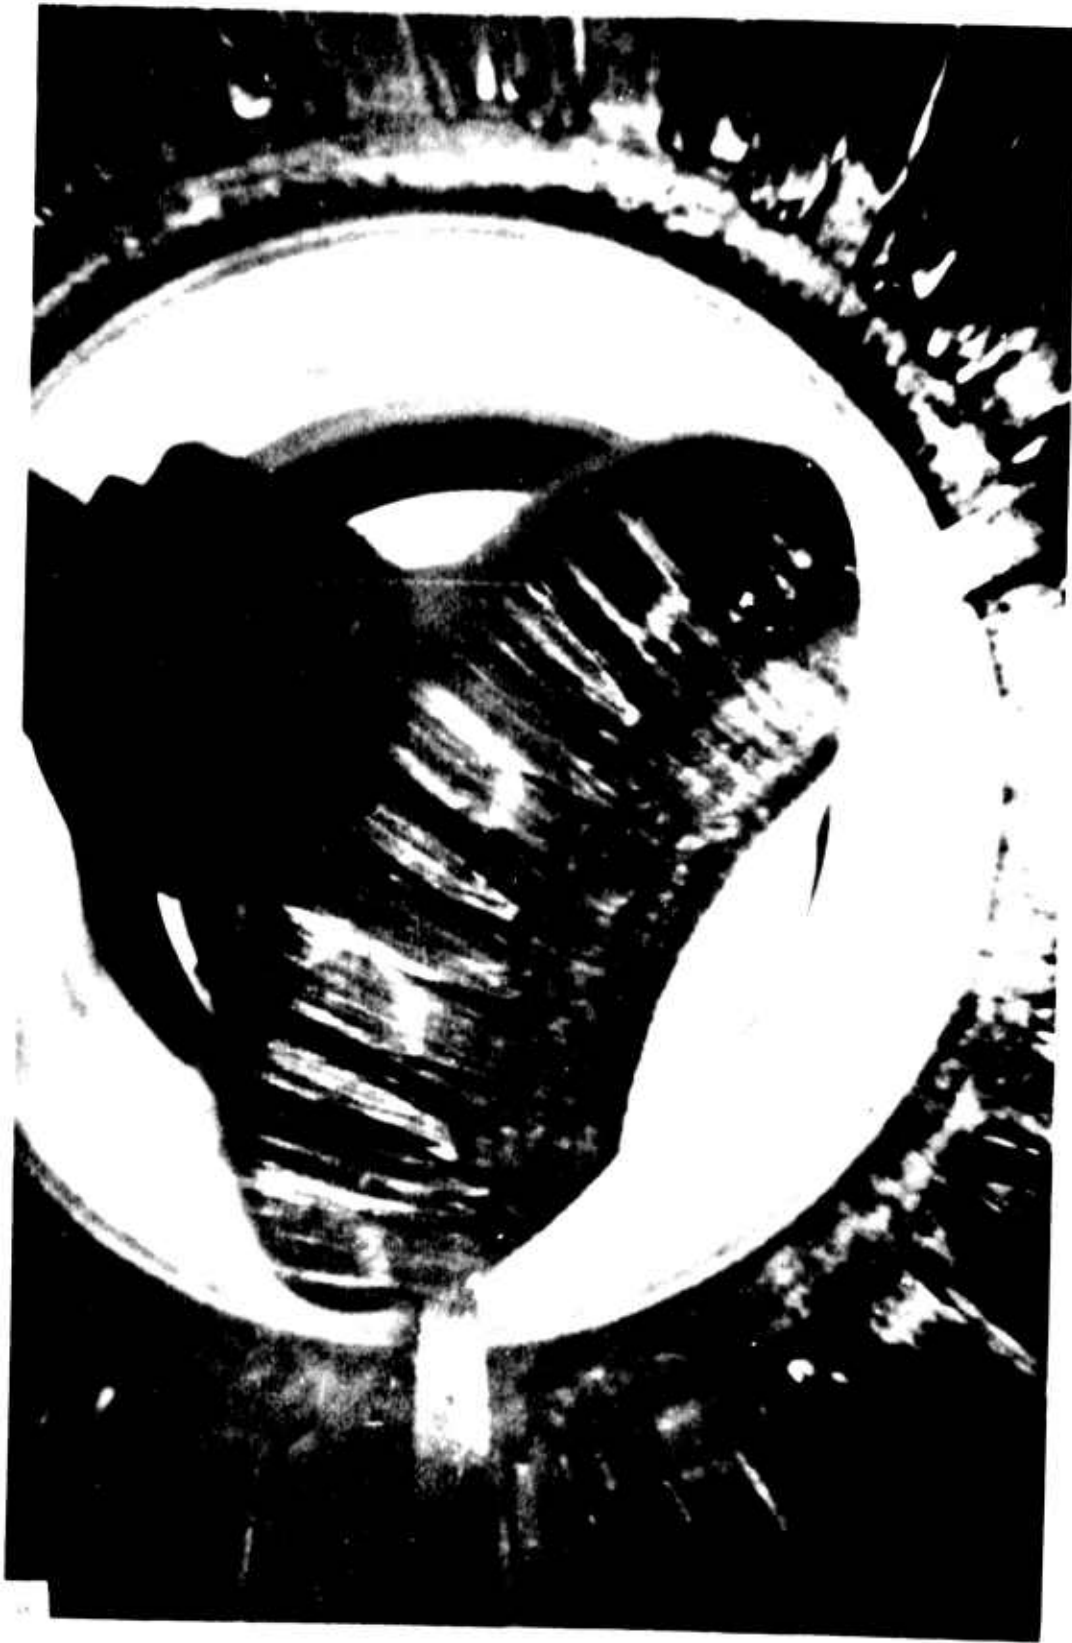
PHOTOGRAPH 27

40mm Mann Barrel after 5486 rounds.
